FTC-TR-70-8

**CATEGORY II  
PERFORMANCE AND  
FLYING QUALITIES TESTS  
OF THE HH-53C HELICOPTER**

TECHNICAL REPORT No. 70-8

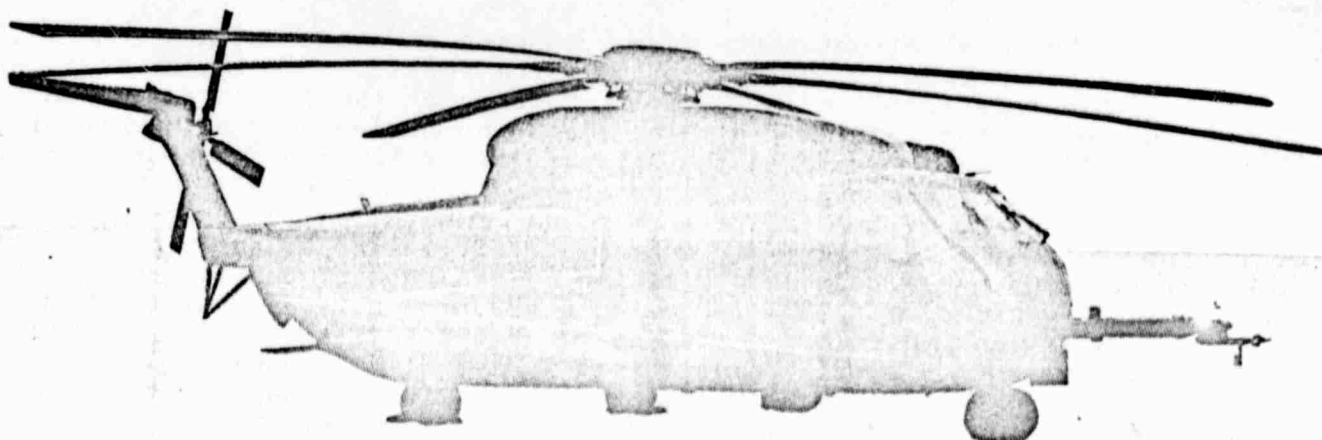
Figure 1

During the level flight portion of the test program a limited evaluation was conducted with both engines equipped with engine air particle separators (EAPS) to determine the effects on performance. The EAPS was designed to remove foreign particles from the engine inlet air. For the condition investigated with the EAPS installed, power-required increased as much as 9 percent. A typical EAPS installation is shown in figure 1; figure 2 shows the helicopter not so equipped.
